QA-223

Burrisville Methodist Church  
Burrisville

## INVENTORY FORM FOR STATE HISTORIC SITES SURVEY

Burrisville Methodist Church

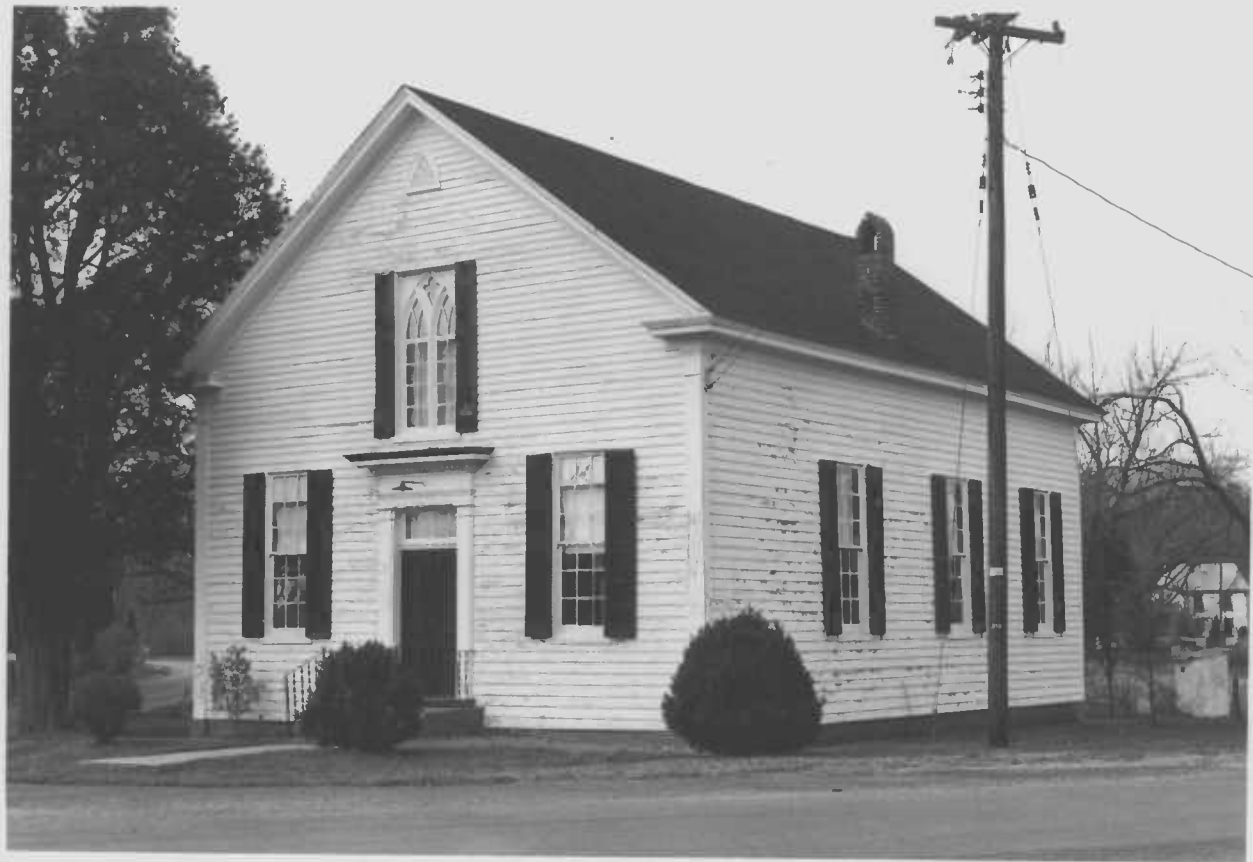
QA-223 Burrisville Methodist Church  
Burrisville, Maryland  
Orlando Ridout V 1981  
Front facade from East

The principal entrance is centered on the southeast gable, and consists of a pair of paneled doors with a four-light transom, set off by a pilastered door surround and an ornamental hood with a dentil block cornice. A single nine-over-nine window flanks the door on each side, and a large window with a Gothic arched opening is located directly above the door. This window is composed of two 8-light, arched sash below a Gothic quatrefoil. The upper lights of the arched sash have translucent glass, while the lower lights are clear. A small trefoil ventilator is centered in the upper gable.

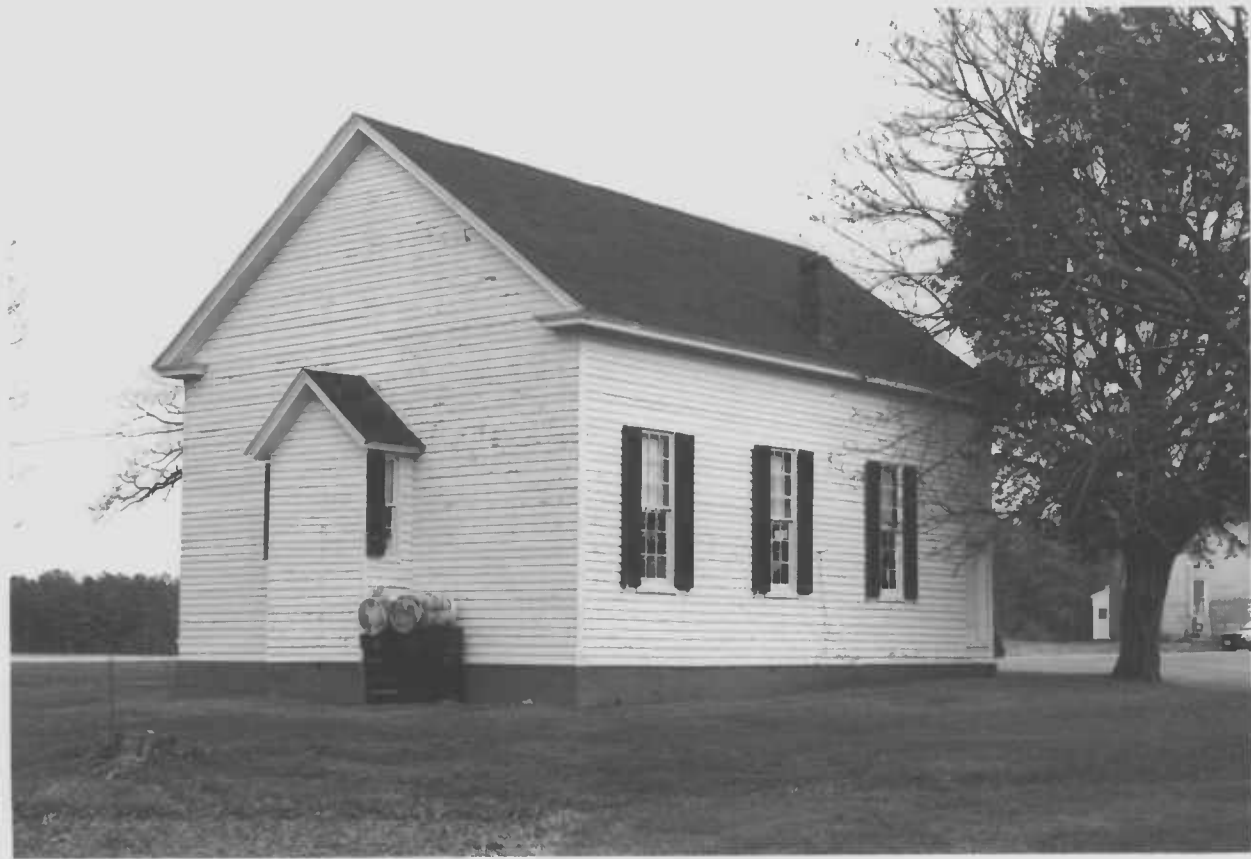
QA-223 Burrisville Methodist Church  
Burrisville, Maryland  
Orlando Ridout V 1981  
Rear facade from West

There are no windows in the northwest gable, but a small chancel with a pitched roof projects from the center of the wall. A single tall, narrow two-over-two window is located on each side wall of the chancel.

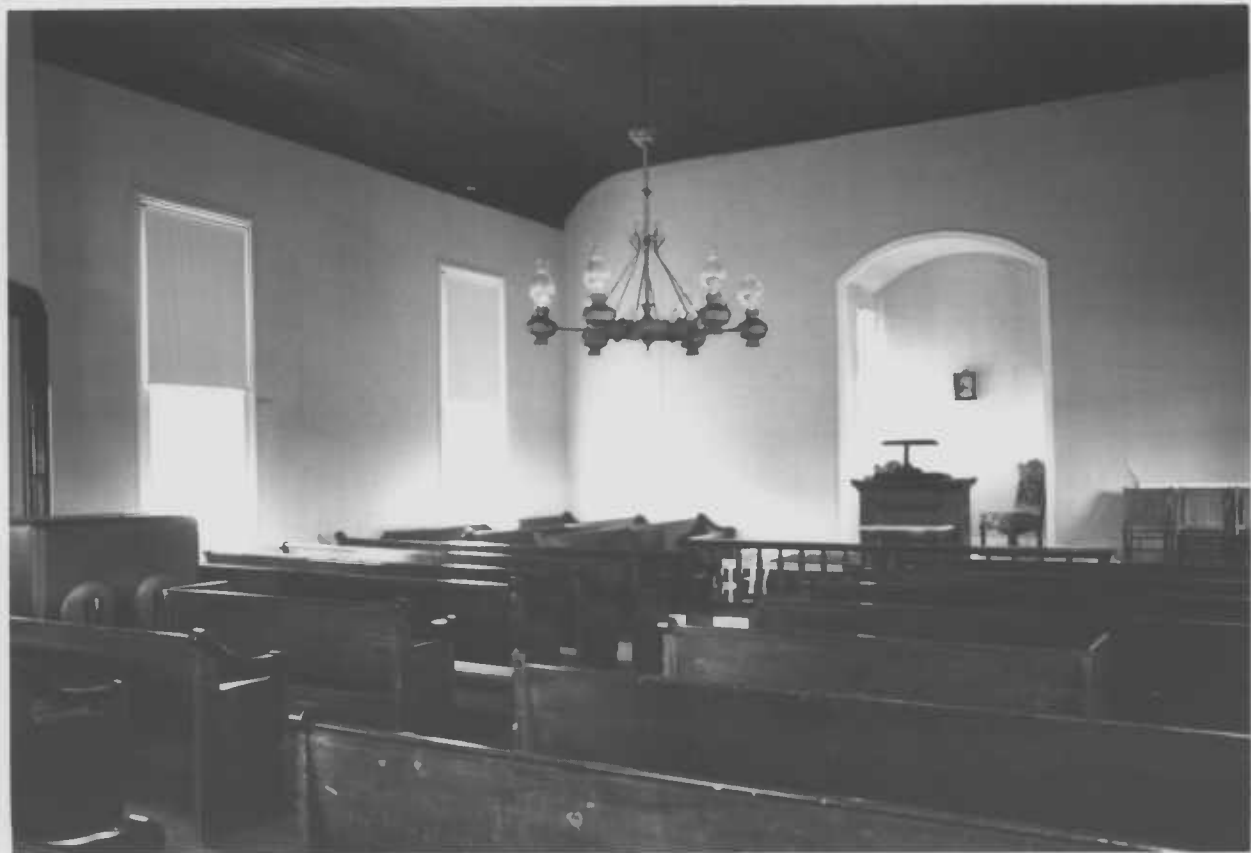
QA-223    Burrisville Methodist Church  
          Burrisville, Maryland  
          Orlando Ridout V 1981  
          Interior View from Door

The interior consists of a single large room, with the pulpit located on a raised platform directly in front of the chancel at the northwest end of the building. A molded railing with square newels and scrolled "splat" ballusters encloses the platform. An original gallery stretches across the southeast end of the sanctuary. It is supported by two square posts flanking the center aisle, and is enclosed by a solid railing decorated with applied moldings that form two elongated panels on the front face of the gallery. There is a small closet below the northeast end of the gallery and a small, enclosed stair hall below the southwest end.

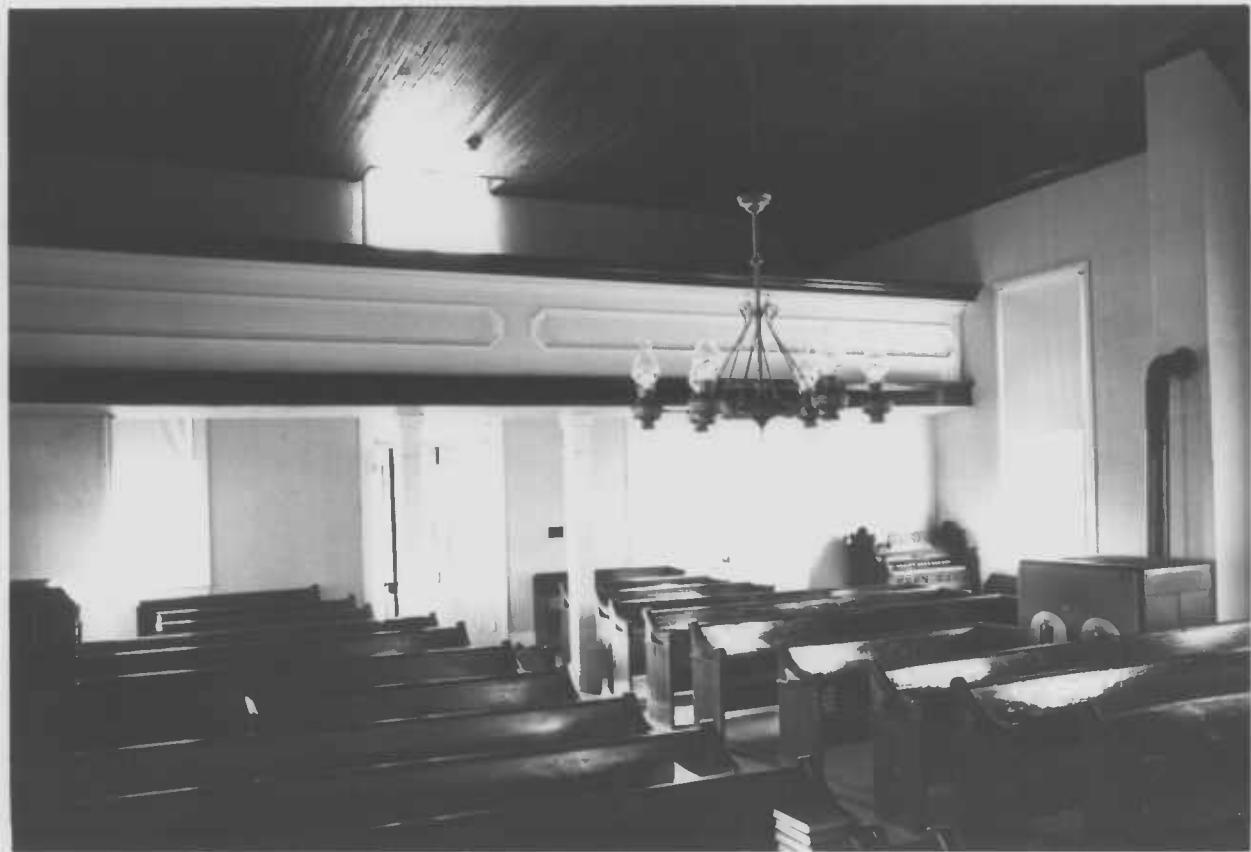
QA-223 Burrisville Methodist Church  
Burrisville, Maryland  
Orlando Ridout V 1981  
Interior View from Altar

The pews are arranged on either side of a center aisle. These are of particular interest because the seats, arms, and edge moldings are stained walnut brown, while the backs and sides are painted and grained an ochre-brown color. Graining is also

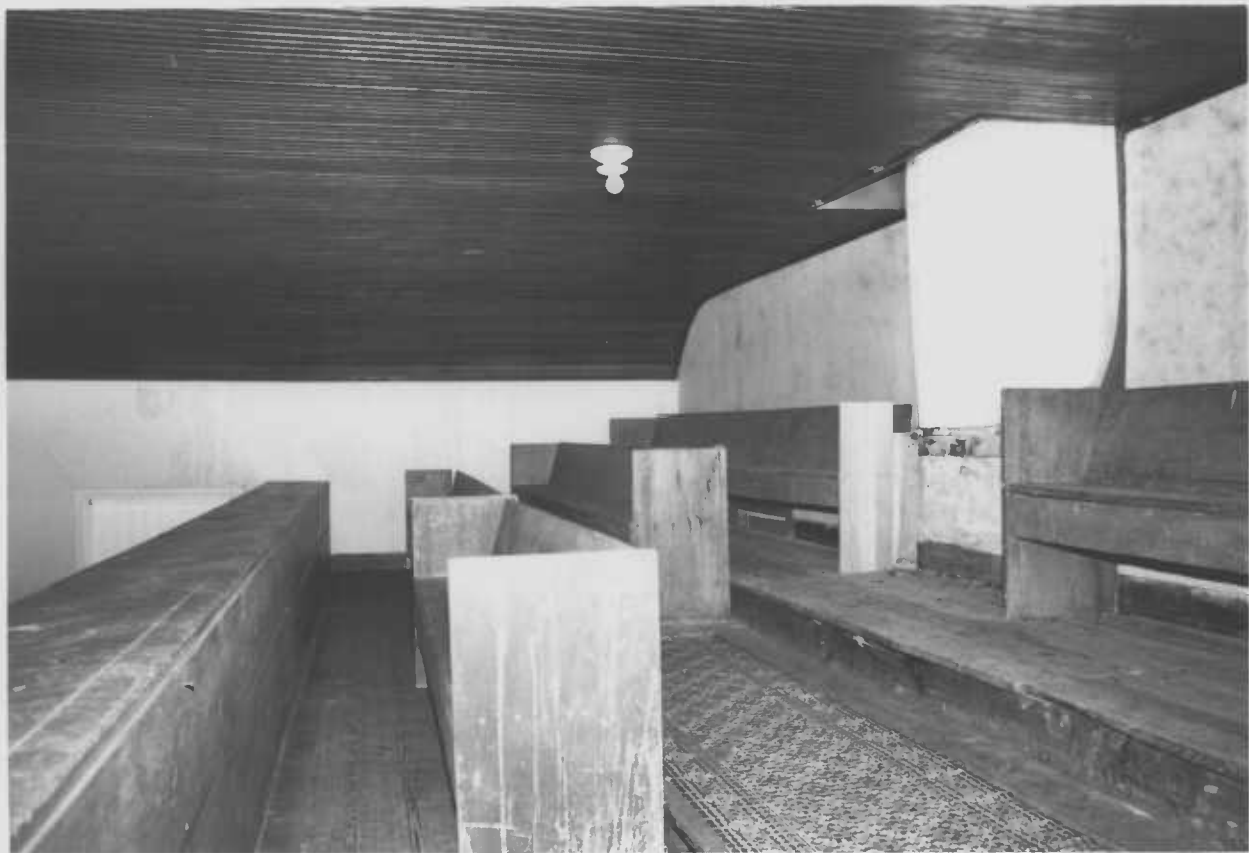
QA-223 Burrisville Methodist Church  
Burrisville, Maryland  
Orlando Ridout V 1981  
Interior View-Gallery

The stairway to the gallery is in the small vestibule or stairhall in the south corner of the building. This vestibule also serves the exterior door located on the southwest facade. This arrangement allows parishioners using the gallery to enter directly from the exterior, without passing through either the principal entrance or the nave. Certainly this lends credence to the tradition that both the gallery and the side door were intended for slaves and/or free blacks. The plain, unfinished state of the gallery, as well as the simple pine benches only serve to reinforce this tradition.
